Analysis of The Causes of Failure in The Crude Oil Transmission of PT PQR: Segment BS CLM–BS CMS

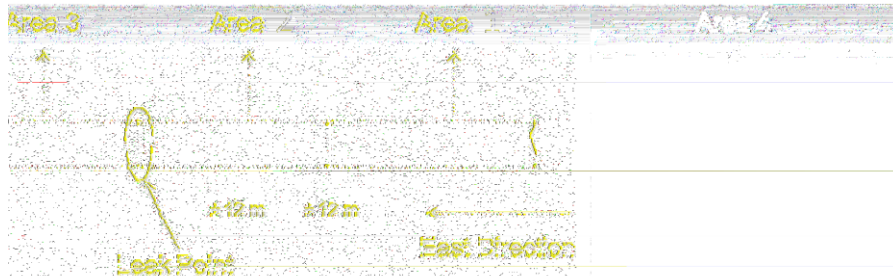
Figure 2. Thickness Measurement Points on the Pipeline

The pipeline measured thickness, as presented in Table 2, indicate that the nominal thickness of the pipeline is 8.18 mm. Measurements at various positions (0°, 3°, 6°, and 9°) show consistent thickness values across most areas, except for the locations identified as leak-prone. At the 6 o'clock position, the thickness was reduced to 0 mm, indicating complete material degradation due to severe internal corrosion. Similarly, the 9 o'clock position displayed significant thinning, with a thickness of 6.85 mm, suggesting localized material loss. These findings highlight the critical areas where corrosion has had the most impact, particularly at the bottom of the pipeline (6 o'clock position), which is prone to fluid accumulation and prolonged exposure to corrosive agents. The 9 o'clock position also shows notable thinning, likely influenced by the flow dynamics or sedimentation effects within the pipeline. This analysis underscores the need for improved corrosion mitigation strategies, such as enhanced drainage systems, internal coatings, and more effective separation of produced water from the transported crude oil.

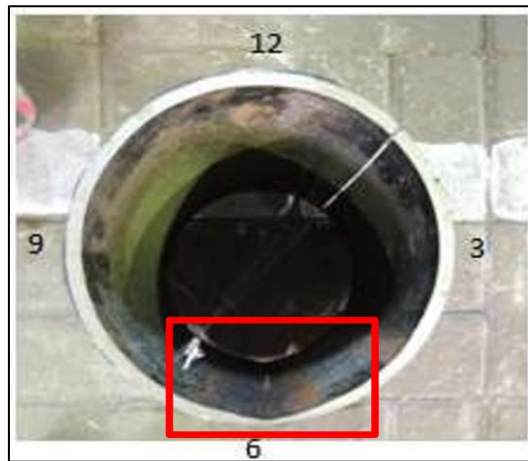
Figure 3. Visual Inspection of Pipeline Thinning

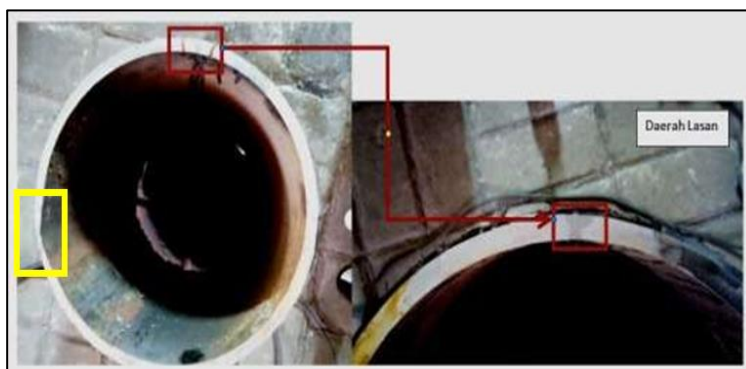
Figure 4. The HAZ Area Did Not Experience Failure/Thinning

The chemical composition inside the failed pipe showed no significant differences, indicating that the failed pipe conforms to the API 5L Grade B standard. The chemical composition of elements such as C, S, P, Mn, Ti, and Fe remains within the acceptable standard limits [13]. Thus, it can be concluded that the pipe still meets the API 5L Grade B standard. Visual inspection revealed that the failure point was not located in the Heat Affected Zone (HAZ). The pipe leakage occurred in the main body of the pipe, specifically at the 6 o'clock position.

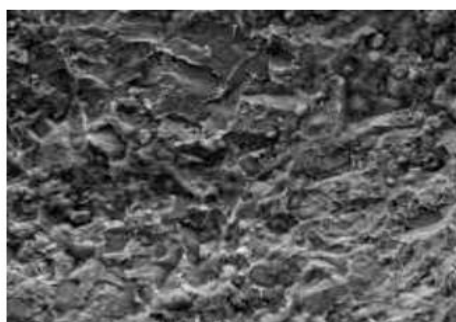
Figure 5. Siderite (Fe_2CO_3) scale

The corrosion product analysis indicates that the majority of the corrosion by-products consist of siderite (Fe_2CO_3), contributing 53% of the total mass. This confirms that iron carbonate formed due to the reaction between dissolved CO_2 in the process fluid and the pipeline material. Hematite (Fe_3O_4), a common iron oxide, constitutes 21%, indicating further oxidation. The remaining 26% consists of elemental iron (Fe), suggesting unreacted pipeline material or remnants of partially corroded metal. These findings highlight that the primary corrosion mechanism is chemically driven by CO_2 exposure and oxidation.

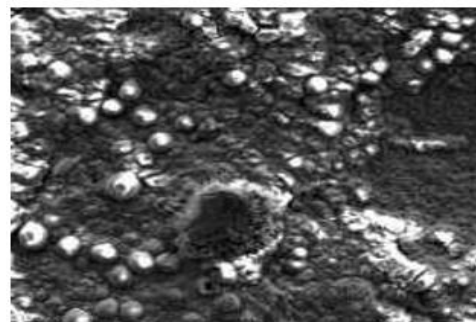
Figure 6. Fe_3O_4 scale

Scanning Electron Microscopy (SEM) was performed to study the surface morphology of corrosion products on the metal surface [16]. The corrosion products formed are generally in the form of an insoluble mixture [1]. The SEM analysis of the corrosion products on the failed pipe revealed that the dominant corrosion products were oxides (Fe_3O_4) and carbonates (Fe_2CO_3). Most of the corrosion products on the failed pipe contained Fe, O, and C components. The percentage composition of these elements was as follows: Fe ranged from 46–63 wt%, O ranged from 24.37–46.28 wt%, and C ranged from 8.84–4.66 wt%. These three elements combined to form iron oxide and carbonate compounds as the main corrosion products.
