## Structural Damages Identification and Maintenance Design of Sports Facilities for Improving Performance and Infrastructure Resilience

Building maintenance is vital to ensure facility reliability, security, and investment value, as neglect can lead to structural decay and safety hazards. This study aims to assess the deterioration level of sports facilities at PT SIER and devise an efficient maintenance plan. The process involves identifying structural damages, evaluating deterioration following guidelines, and planning maintenance actions. Subsequent steps include budgeting, creating Work Plans and Specifications, estimating Domestic Component Levels, and scheduling using the S-Curve. Analysis reveals varying degrees of architectural degradation, ranging from 1 to 3, signifying serious damage. The estimated total cost for upkeep and development is Rp 255,718,000, with a projected minimum Duty and Customs Levies value of 30.43%. Maintenance duration is estimated at 45 days, managed using the S-Curve method.

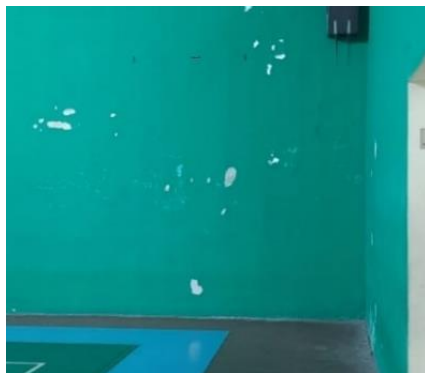
(a)

The condition of the badminton hall area was assessed and displayed in Figure 2. The inner walls of the badminton hall exhibit peeling in specific areas with varying degrees of severity. This affects the aesthetic appearance of the room and also reduces the wall's protection against moisture and dust. Damage to the inner walls is illustrated in Figure 2 (a). The kalsiboard walls exhibit fractures in certain areas, especially those directly exposed to the weather. Extreme temperatures are the cause of these fractures in the kalsiboard. Damage to the kalsiboard can be observed in Figure 2 (b).

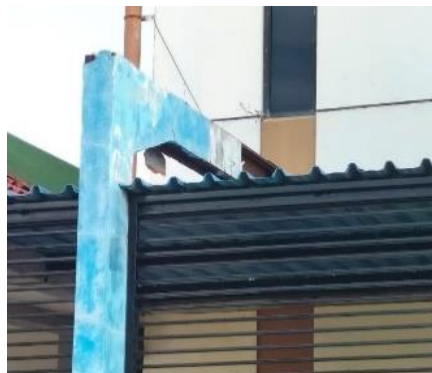
(b)

No	Component	Damage Condition	Damage Level Score
<b>Badminton hall area</b>			
1	Interior wall paint	The paint on the interior walls of the badminton hall is peeling	3 (Moderate)
2	Kalsiboard wall	Kalsiboard is broken	1 (Severe)
3	Naturalstone coating	Coating on natural stone is peeling	3 (Moderate)
4	Floor hinge	The floor hinge is worn out, and unable to hold the door leaf swing	1 (Severe)
5	Cock replica	Galvanized pipe components of the cock replica are rusted and corroded	1 (Severe)
6	Galvanized pipe "GEDUNG"	Paint on galvanized pipes is peeling and rusting	3 (Moderate)
7	BADMINTON SIER" sign	Paint on the sign is rusted	3 (Moderate)
<b>Area Lapangan Multifungsi</b>			
8	Kalsiboard wall	Kalsiboard is fading in color	3 (Moderate)
9	Natural stone	Some areas of the natural stone are detached from the pillar. Coating on natural stone is peeling	1 (Severe)

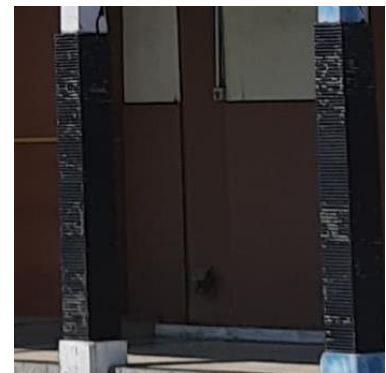
(c)

The natural stone coating layer experiences peeling due to extreme weather conditions, affecting the coating's quality and making it brittle and prone to peeling. This damage falls into the category of moderate damage, requiring maintenance. Damage to the natural stone coating can be seen in Figure 2 (c). The cock replica has experienced corrosion and rust across its entire area. Galvanized pipes placed in outdoor areas are directly exposed to sunlight, rain, and extreme weather, causing corrosion and rust. This damage has the potential to reduce the durability and strength of the pipes in bearing loads. Damage to the cock replica can be seen in Figure 2 (d). The pipes on the facade of the badminton building experience rust in certain areas. Corrosion of galvanized pipes is caused by direct exposure to sunlight and temperature fluctuations. Damage to the facade pipes can be observed in Figure 2 (e). The lettering exhibits rust in certain areas due to direct exposure to temperature changes and weather conditions. The condition of the lettering is shown in Figure 2 (f).

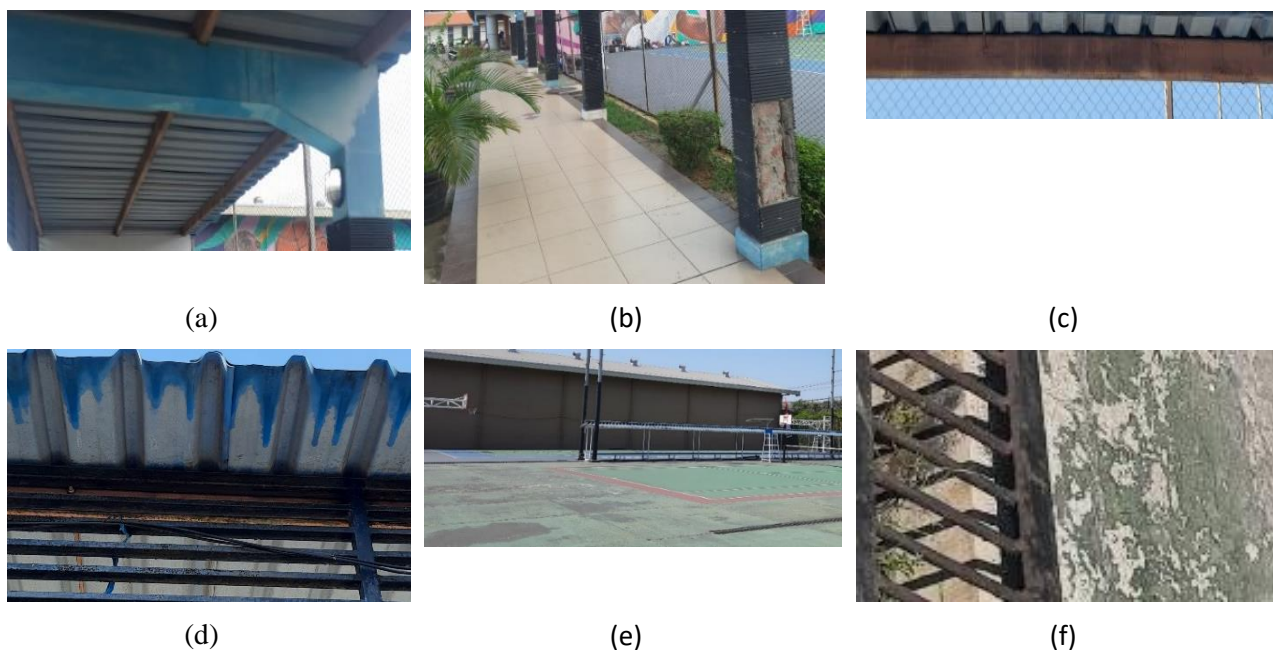
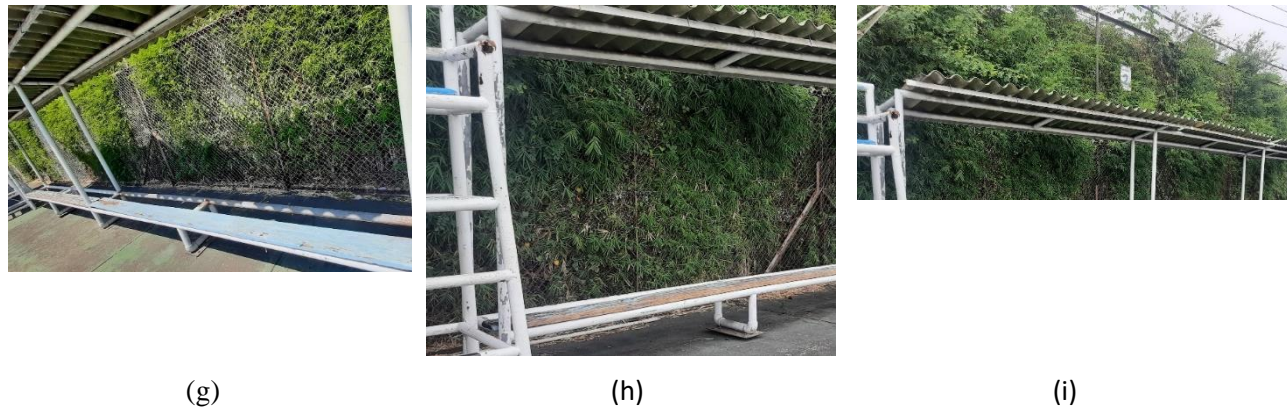
**Figure 3.** The architectural component damage in the multipurpose field area

The kalsiboard experiences color fading of paint (Figure 3 (a)). Damage to the natural stone includes the detachment of some stones from the pillars, posing aesthetic and safety concerns for users (Figure 3 (b)). Poor installation and inadequate mortar or plastering that fails to meet standards are among the causes of stone detachment. Additionally, the coating layer on all natural stones peels off. Girders exhibit rust across their entire area (Figure 3 (c)). Hollow sunscreens experience erosion at specific points and rust along the entire hollow area. The outer play area of the tennis court experiences color fading of the paint. This area is commercially used for tennis court rental, so aesthetic aspects are crucial. Drainage grills experience rust throughout their area (Figure 3 (d)). The drainage on the multipurpose field is covered by iron grills. There are benches missing wood on one side (Figure 3 (f)). The wood has dimensions of 3.8 x 0.2 m and 2.8 x 0.2 m. Additionally, all benches experience paint peeling (Figure 3 (g)). Damage to these benches results in suboptimal load-bearing capacity and the potential for more severe damage, necessitating replacement and maintenance (Figure 3 (h)). Bench posts made of iron experience paint peeling in certain areas. Bench roofs are broken in several areas, causing leaks and rendering the roof ineffective as protection (Figure 3 (i)).

No	Component	Damage Condition	Damage Level Score
10	Gording	Gording is rusting	3 (Moderate)
11	Hollow sunscreen	Several hollow areas are corroded. Hollows are corroded	1 (Severe)
12	Outdoor tennis play area	The outdoor tennis play area is fading in color	3 (Moderate)
13	Drainage grill	Drainage grill is rusted	3 (Moderate)
14	Bench	Some benches lack seats. Wooden benches are peeling paint	1 (Severe)
15	Bench pole	Bench poles have peeling paint	3 (Moderate)
16	Bench roof	The asbestos bench roof is cracked, causing leaks	1 (Severe)
