Damage Assessment Method for Light Steel Roof Frames: Case Study of Government Buildings

The tornado disaster in Ciamis Regency damaged 55 buildings, including the Panawangan District Office. The aim of this research was to identify the condition and level of damage to the Light Steel Roof Frame Structures that were damaged and determine the ranking or percentage of damage. By making direct observations at the location of the incident. The result is that: The roof covering element uses zincaluminum metal with the batten frame partially damaged on the left side of the building above the hall and the right corner of the front of the building. The bottom chord, top chord and web elements are partially detached. The trim element made of GRC material is damaged. came loose, and the Gypsum ceiling elements with hollow frames fell on the outside and inside the hall. The percentage of damage obtained is 14.50% and the damage level $\leq 30\%$ is categorized as Light Damage.

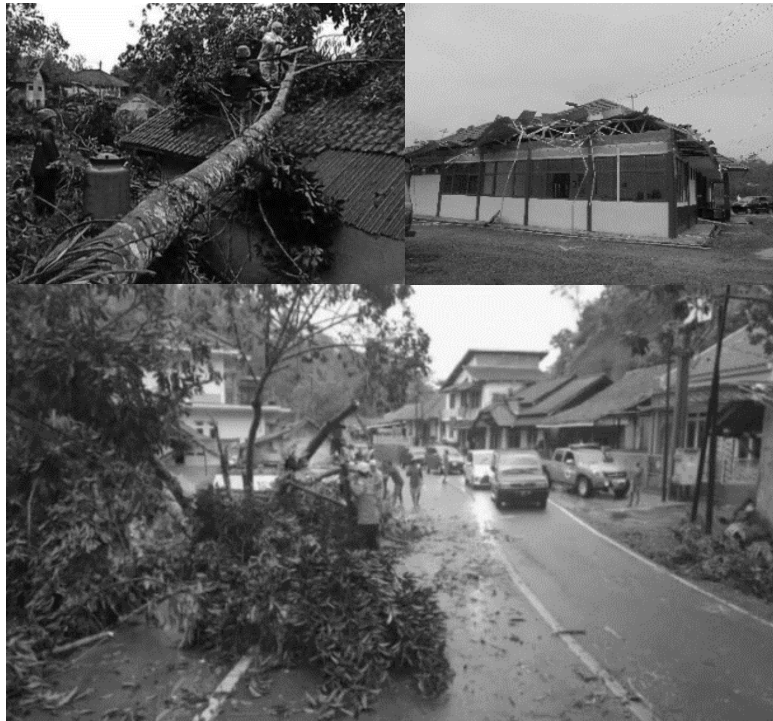
The tornado disaster occurred in Ciamis Regency, West Java, located in Panawangan District on Wednesday, January 4, 2023, at 15:43, strong winds accompanied by heavy rain destroyed the buildings in its path, damaged 55 houses, the Panawangan District office, schools, and mosque. Apart from that, a number of fallen trees blocked roads and hit houses. (M Dani, 2023) are seen in Figure 1.

Figure 1. Impact conditions after a tornado in Panawangan District

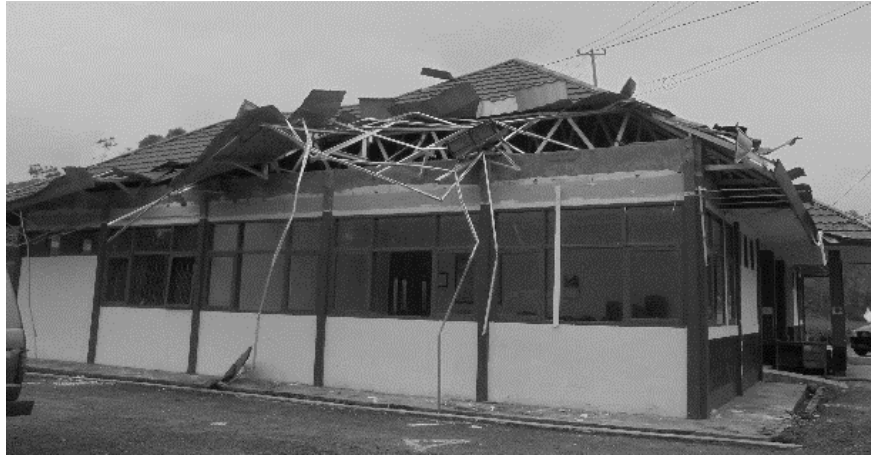
Figure 2. The roof frame of the side of the building was damaged.

It can be seen in Figure 2 that the Panawangan District building with a building size of 15 x 21 m, one floor is used for the District Office, on the side of the building below which is intended for hall space, the roof of the building which is made of light steel frame is damaged, with the roof covering elements using multi-roof lifted and separated from the Batten section.

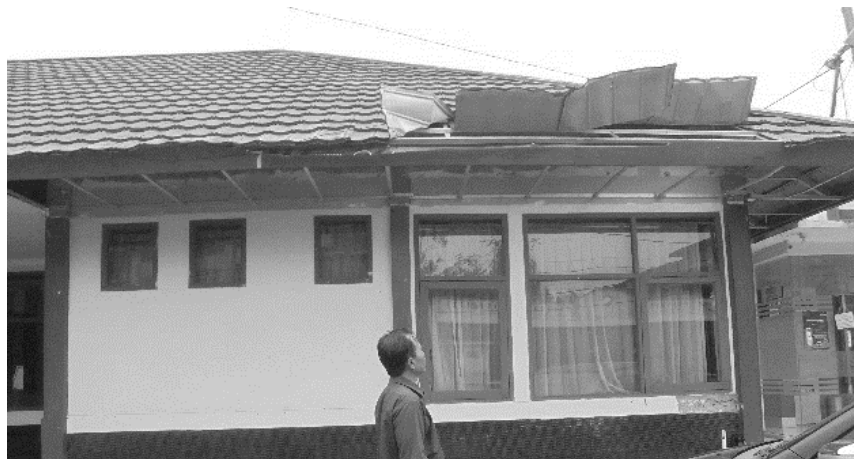
And on the right side of the Panawangan District Office building, there is a detachment of the roof covering element, and part of the ceiling which was installed from Gypsum material is detached from the frame, as seen in Figure 3.

Figure 3. The right roof and ceiling cover came off.

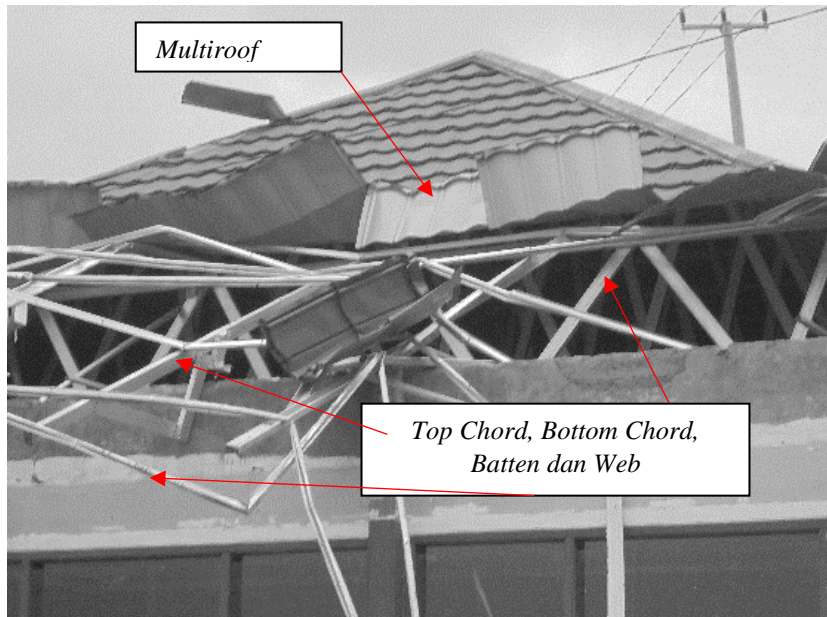
Figure 4. damaged of parts of the frame and roof.

Parts of the light steel frame structure, namely Top Chord, Bottom Chord, Web, and Batten which can be seen in Figure 4, were partially damaged and parts of the roof covering made of multiroof material came off, and other parts of the building roof were damaged, especially the reinforcing parts of the lightweight steel roof frame that connects the building and the roof frame is the L Bracket because this element strengthens the roof frame and the building to be stable. In fact, the L Bracket which should be strong enough to hold the roof frame from the building base is separated from its base, as seen in Figure 5.

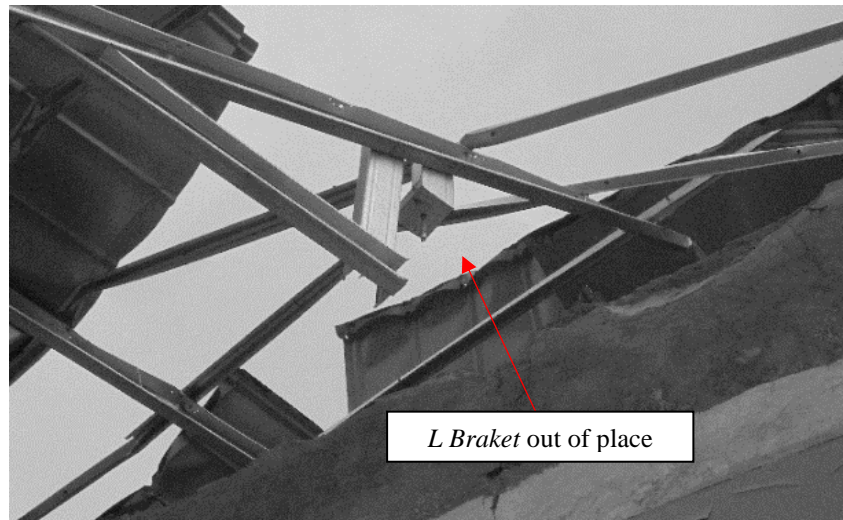
Figure 5. The *L Bracket* element is detached from its mount

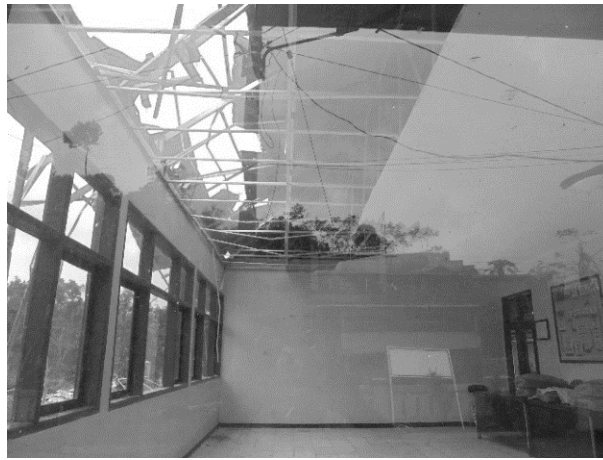
The covering ceiling made of Gypsum was damaged on the outside and inside of the building, especially above the hall, as seen in Figure 6.

Figure 6. The gypsum ceiling cover fell

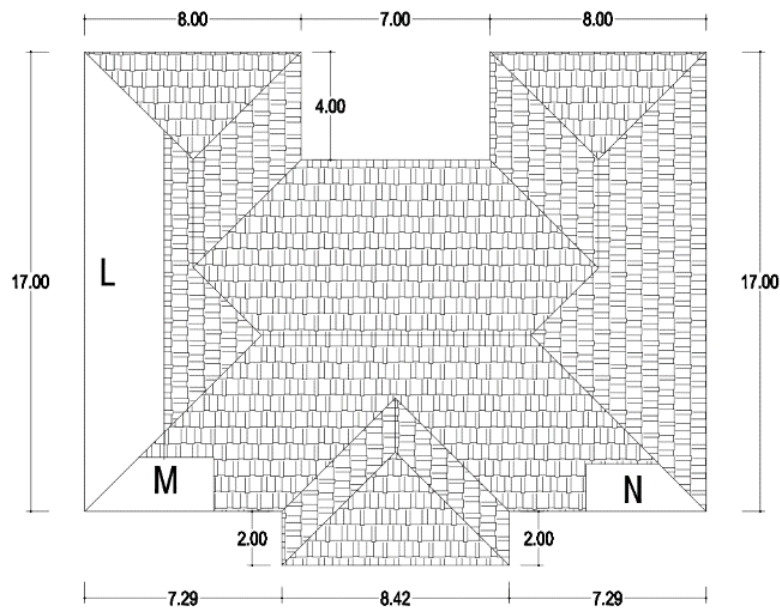
Figure 8. Sketch of the damaged roof plan with codes L,M and N

Code	Flat area m ²		Slope 30 ⁰		Roof area m ²
L	41,3	x	1,16	=	47,91
M	7,5	x	1,16	=	8,70
N	6,3	x	1,16	=	7,31
Total amount				=	63,92

- % Area of Damage = ((Area of Damage)/(Total Area)) x 100%
- Total damage area = 63,92 m²
- Total area = 441,03 m²
- % Area of Damage = (63,92 / 441,03) x 100%
= 14,50 %

The percentage shows the damage value is 14.50%, which means that the Panawangan District office building as a result of a tornado accompanied by heavy rain is in the Lightly Damaged (LD) category, because according to the Ministry of PUPR, the determination of the level of damage to buildings is based on a quantitative measure of the magnitude of the damage that occurred. for each component, the results obtained from calculating the damage to the roofs of buildings in Panawangan District were at a damage level of ≤ 30%, categorized as Lightly Damaged.
