## Evaluation and Strengthening Recommendations of Rectorate Building Muhammadiyah University of Sumatra Barat Due to Earthquake

Asiya Nurhasanah Habirun\*, Deddy Kurniawan, Muhammad Fajri Ad'ha  
Department of Civil Engineering, Faculty of Engineering, Muhammadiyah University of Sumatra Barat

### Abstract

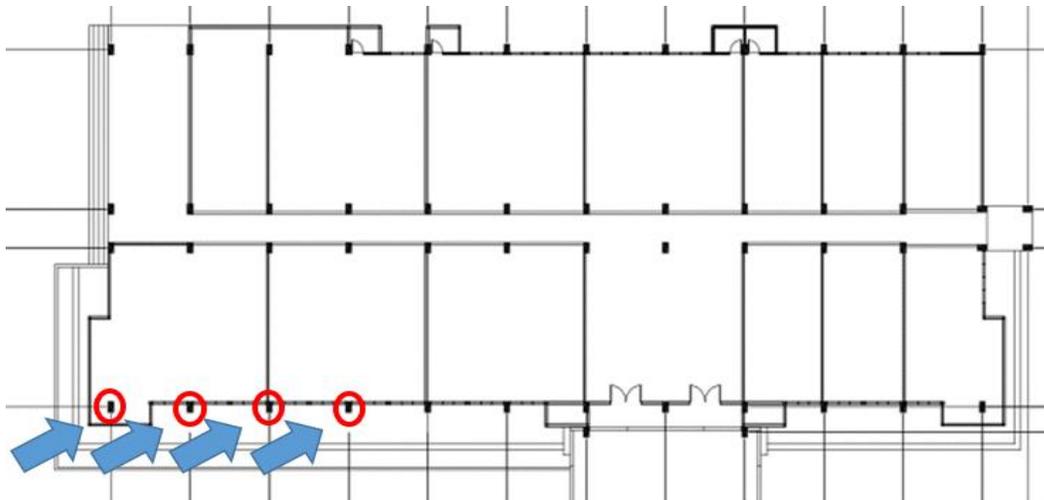
Columns on floors 1 – 3 are damaged and some of them has wide cracks which exposed the reinforcement and corroded (Figures 3 and 4). The majority of cracks occur at the column support area. So that it can be categorized as a column experiencing shear failure. Some beam elements have undergone permanent plastic deformation or deflection. Most of the beams experienced cracks in the support area. This is an indication of shear failure (Figure 5). One of the reasons for the deflection of the beam is due to the relatively long span of about 9.25-meters without any joists or columns in the middle of the span. The capacity of the beam exceeds the internal force so that cracks occur.

**Figure 3.** Map of the column locations that suffered the most severe damage.

Based on the results of the analysis, it is necessary to re-plan to reduce the risk of a balance failure. But there are some suggestions to apply the strengthening of the building. Cracks and failures in the column structure are strengthened by increasing the cross-sectional capacity of the structural elements using the concrete jacketing method, so that the cracks in the exposed columns and reinforcement can be closed again. Reinforcement of beam elements is not recommended using Carbon Fiber Reinforced Polymer (CFRP). Under actual conditions, beams require more than 3 layers of CFRP to increase structural capacity. However, the addition of CFRP above 3 layers provides less optimal performance (Sumargo et al., 2014). The ductility of the building needs to be improved by adding columns and joists to reduce the deformation that occurs. The building has a fairly long span of 55 meters. It is necessary to apply a dilatation system by dividing the building into 2 (two) parts in the middle of the span. So that it has a separate center of mass of the building and reduces the risk of shear failure. The results of the upper-structure strengthening plan need to be retained by the substructure. So that further investigation is needed on the capacity of the foundation and soil conditions. The investigation will simultaneously answer the cause of the decline in the building.

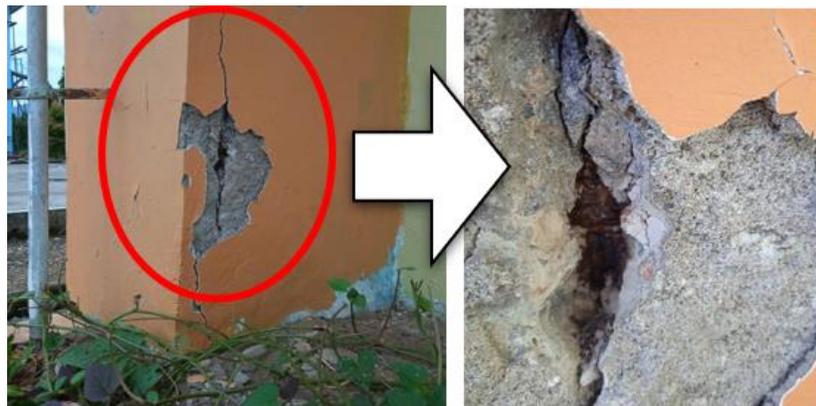
**Figure 4.** The column has a crack wide enough at the supports (1/4 span) to expose the reinforcement and corrode.

There are several possible causes for this damage, namely that the location of the establishment was in an earthquake area. During the 33 years of the building's existence, several earthquake phenomena with quite high magnitudes have occurred. During its lifetime, post-earthquake structural handling has never been carried out. On the other hand, the planning standards applied to buildings in 1990 do not yet apply to the latest planning standards like today. The growth of cracks in structures has become increasingly clear in the last 5 years due to a maximum magnitude 6 earthquake.

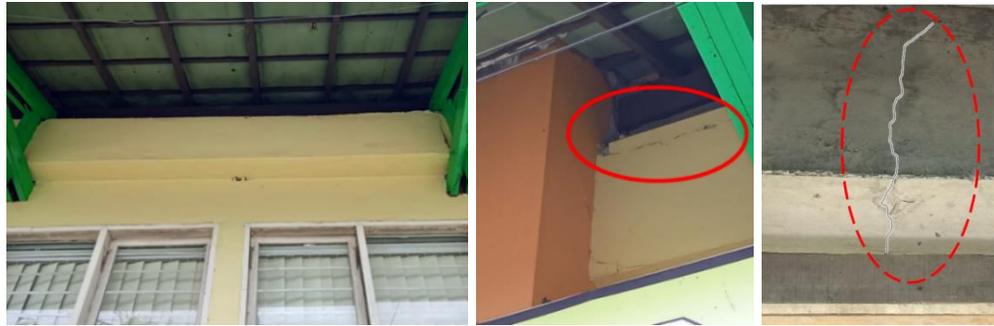
**Figure 5.** Beam experiencing permanent deflection (left) accompanied by cracks in the support area (middle) and bending cracks (right)

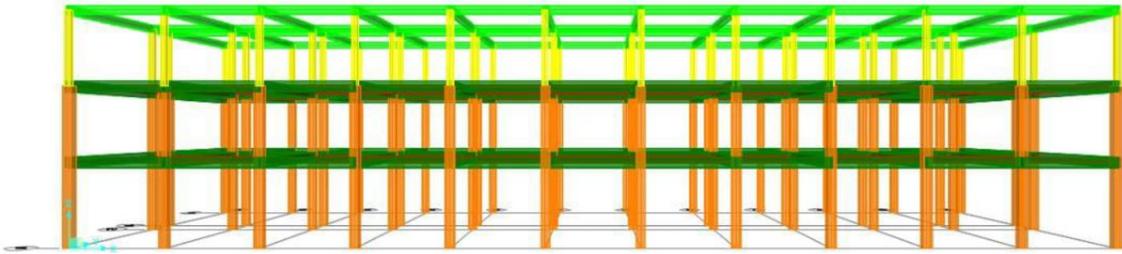
**Figure 6.** Building structure modeling in SAP2000 v. 21

The results of the structural analysis show that the main column K1 (45 x 45) has experienced excess capacity. The ratio of reinforcement to the cross-section of the existing column is 0.8%. This value is below the cross-sectional ratio requirement which ranges from 1% to 8%. This makes the column unable to withstand the load optimally. Some beam elements have experienced excess capacity where the capacity ratio is greater than 1.0. An indication of collapse has occurred by the presence of cracks in the beams found during visual inspection.

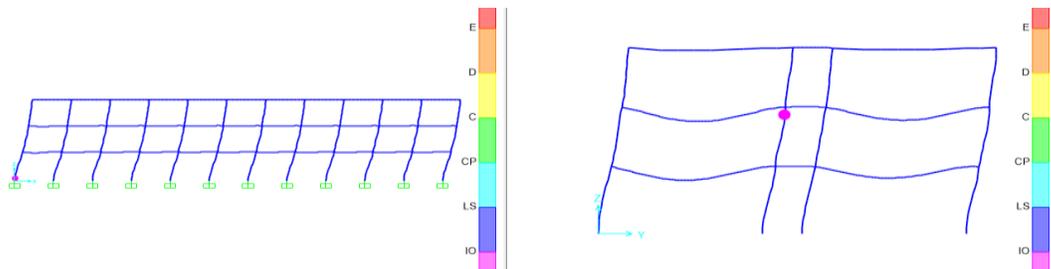
Nonlinear static analysis (pushover analysis) is calculated using the SAP2000 v.21 software. The results show 10 steps and 11 steps of pushing load in the x and y directions on the building structural components until they collapse. The beginning of the plastic hinge occurs in the 1st floor column when the pushing load enters the 2nd step (Figure 7). As the push increases, more plastic joints are formed in the element. Step 8 in the y direction, the plastic joint formed has reached the ultimate capacity (C) in the column shown in yellow (Figure 8). This condition occurs in all 1st floor columns until the pushing load simulation reaches steps 10 and 11 (Figure 9).

**Figure 7.** Deformation of push x (left) and push y (right) in step 2

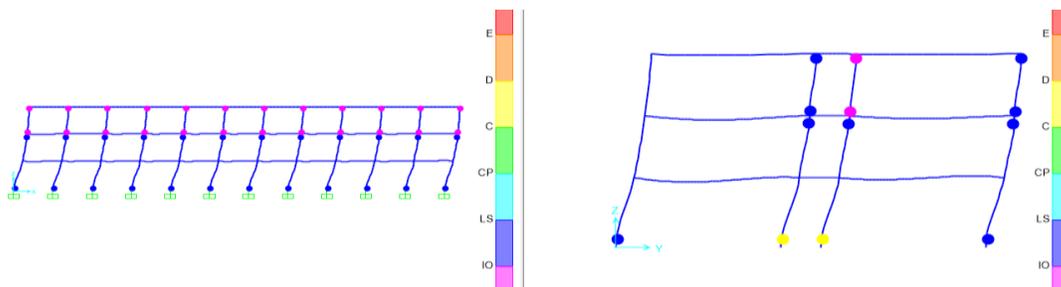
**Figure 8.** Deformation of push x (left) and push y (right) in step 8

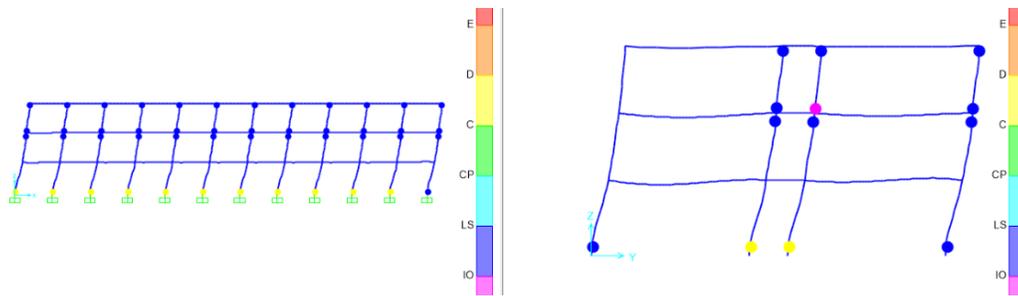
**Figure 9.** Deformation of push x (left) in step 10 and push y (right) in step 11

Achieving the ultimate capacity in the column structure is in accordance with the cracks that have occurred in the current building. It can be said that the location of the column structure with plastic hinges the results of the analysis results are the same as the cracked or broken condition of the column support at the same location in the building. Collapse is caused by a working load greater than the column cross-sectional capacity. The total deviation obtained is 0.02 for the x and y directions. Meanwhile, the maximum inelastic deviation obtained is 0.016 for the x direction and 0.018 for the y direction. Based on table 5.5.4 ATC-40, the structural performance level of the rectorate building is at Life Safety. This means that the structural components are in a plastic condition. If an earthquake occurs, buildings will collapse and there is a significant risk of loss of life. In connection with the conditions that have occurred and seen in the field, the building structure has displayed indications of structural damage and failure.
