Analysis of Induction Motor Performance Using Motor Current Signature Analysis Technique

Abstract - This paper discusses the analysis of the performance of an induction motor using the motor current signature analysis (MCSA) technique. Induction motor is a type of electric machine that is widely used in industry. One of the industries that utilize induction motors is a steam power plant (SPP). The role of induction motors is very vital in SPP operations. Therefore, it is necessary to monitor the performance, stability, and efficiency to anticipate disturbances that can cause damage or decrease the life of the induction motor. MCSA is a reliable technique that can be used to analyze damage to an induction motor. In this technique, the induction motor current signal is detected using a current transducer. The signal is then passed on to the signal conditioning and then into the data acquisition device. The critical signal data is analyzed with inadequate computer equipment. The results of this analysis determine the condition of the induction motor, whether it is normal or damaged. In this research, a case study was carried out at the Rembang steam power plant, Central Java, Indones

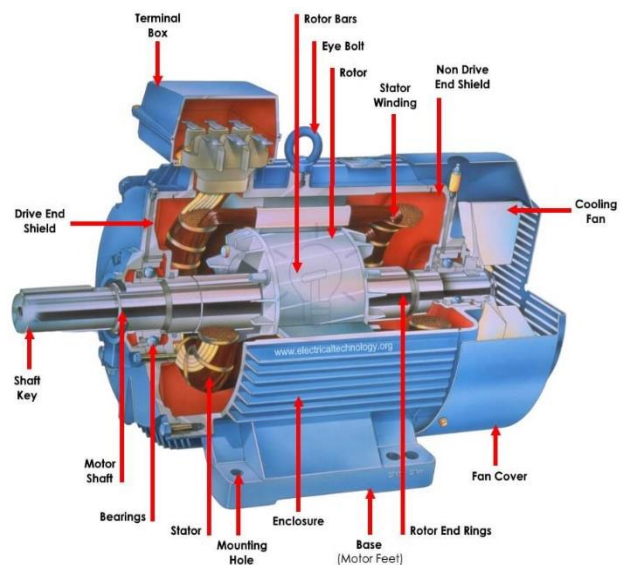
Fig. 1. Typical induction motor construction

An induction motor consists of a non-rotating part (stator) and a rotating element (rotor), as shown in Fig. 1. The stator consists of dynamo blocks that are insulated on one side and have a thickness of 0.35-0.5 mm, arranged into a block package in the shape of a bracelet. Inside is equipped with grooves. There is a difference between an asynchronous motor with a nest winding (a nest rotor or short circuit rotor) and a drag ring with a three-phase winding in this groove. Or, from the other side, the iron core of the stator and rotor are made of layers (enamel) of silicon steel 0.35 - 0.5 mm thick, neatly arranged, each electrically insulated and fastened at the ends.

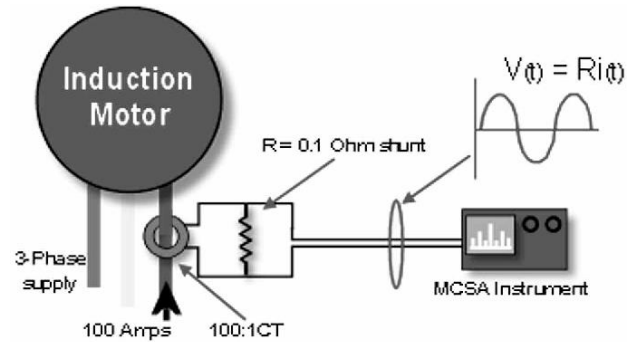
Fig. 2. MCSA procedure

In Fig. 2, it can be seen that the procedure in MCSA is taking current from the winding stator using sensors from the current transformer inside the MCSA probe, then the data is analyzed and stored temporarily in CSi 2130, if there is a disturbance, the data will be analyzed using AMS Healthy Machinery software. Fig. 3 shows a chart of the MCSA data collection process when monitoring the induction motor.

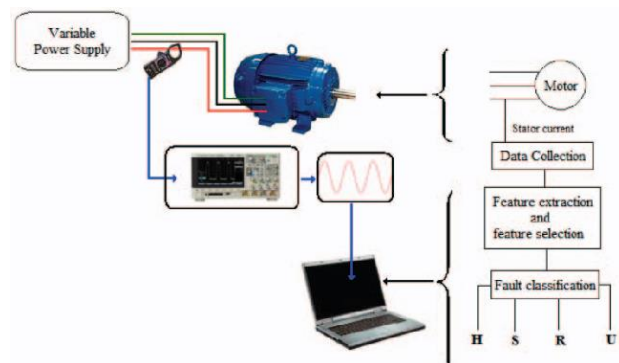
Fig. 3. MCSA data collection process when monitoring the induction motor

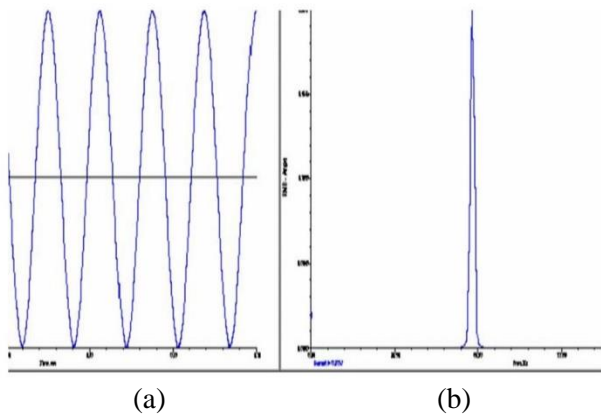
Fig. 4. A 50 Hz signal in the time and frequency domains

A motor current signal is ideally a perfect sinusoidal wave at 50Hz. With pictures, we can represent the current in terms of time as well as frequency. Fig. 4 shows the first image (Fig. 4.a), which is the relationship between current and time, while the second image (Fig. 4.b) shows the relationship between current and frequency. Fig. 4 shows a 50 Hz signal in the time and frequency domains.

The amplitude of the peak frequency is equal to the RMS amplitude of the sine wave. It is theoretical that in the absence of a harmonic, we can see that there is only one peak in the frequency spectrum. Current conversion from time to frequency area is achieved using the Fast Fourier Transform (FFT) algorithm [18]-[19].

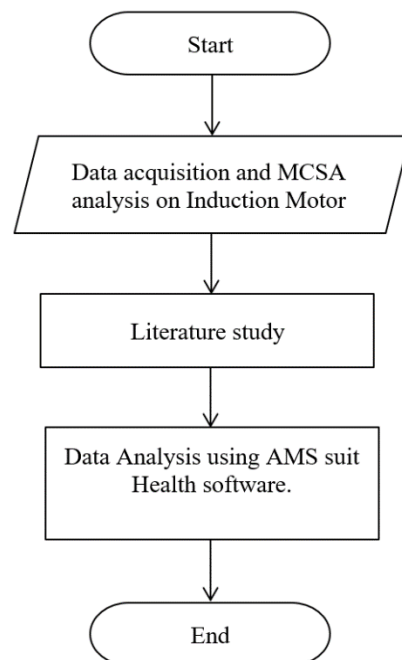
Fig. 6. Flowchart of the research step

The steps of this research are shown in Fig. 6. The initial step of the research was the analysis of the motor. This step is the initial stage carried out in data collection using the MCSA tool on the three-phase induction motor used in PT PJB UBJ O&M SPP Rembang. The next step is a literature review. Literature review is carried out to find information about theories, methods, and concepts relevant to the problem. Based on this information, it can be used as a reference in solving problems. Literature study is carried out by looking for information and references in the form of textbooks, information from the internet and other sources. The final and most important step is data analysis using AMS suit health machinery software. From the analysis using AMS Suite Health Machinery software, an induction motor diagnosis will be obtained which will be analyzed later. The data to be analyzed is the unbalance current output data and the damage to the rotor bar whether the motor is in good condition or not.

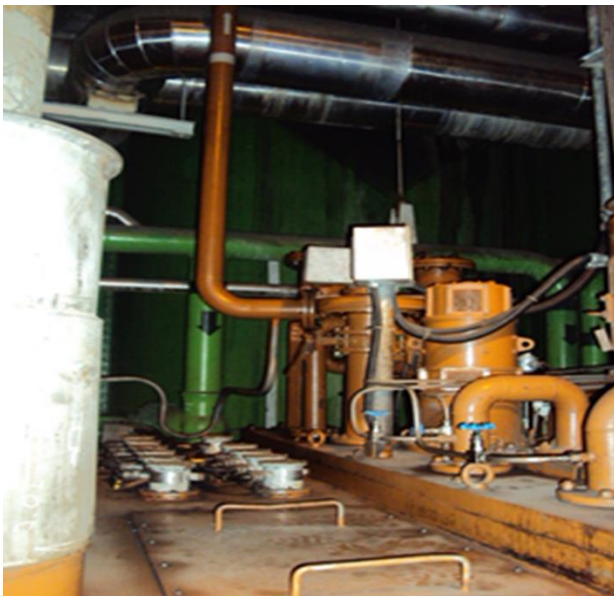
Fig. 7. Motor lube oil bfpt pump in SPP Rembang

This research originated from the problems that occurred in PT UBJ O&M Steam Power Plant (SPP) Rembang. One of the three-phase induction motor units at SPP Rembang had an operation failure. The induction motor unit functions as a driver for the motorized lube oil bfpt pump, as shown in Fig. 7.

The specifications of the three-phase induction motor used in the lube oil bfpt pump motor are shown in Table 1. The motor power capacity is 18.5 kW, the working voltage is 400 volts at a nominal current of 33.9 amperes. The nominal speed of the motor is 2930 rpm, and the system frequency is 50 Hz.

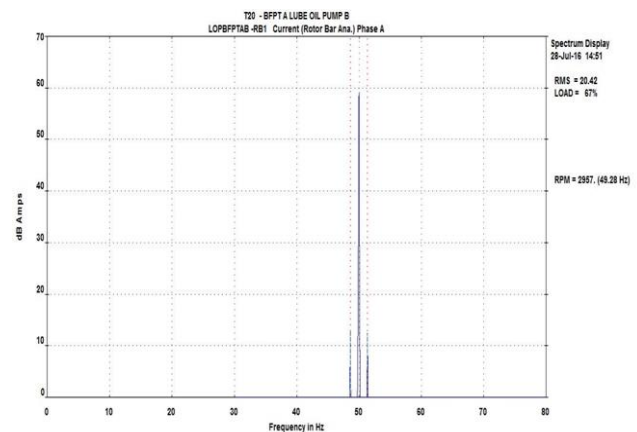
Fig. 8. Current spectrum in the frequency domain from MCSA

The analysis of the rotor bar was carried out to determine the level of damage to the rotor bar. The results of the analysis using the MCSA tool display the current spectrum in the frequency domain, as shown in Fig. 8.

To analyze the condition of the rotor bar on an induction motor, it is necessary to first calculate the frequency of running speed of the induction motor. Based on the operation data of the induction motor, it is found that the motor rotation is 2957 rpm. Thus, the frequency of running speed of the induction motor is 49.28 Hz. After knowing the running speed frequency of 49.26 Hz, to find out the value of the synchronous speed frequency, which is according to the nominal frequency of 50 Hz. By calculating the running speed and the synchronous speed or slip frequency, the side band frequencies that occur around the line frequency can be determined. The

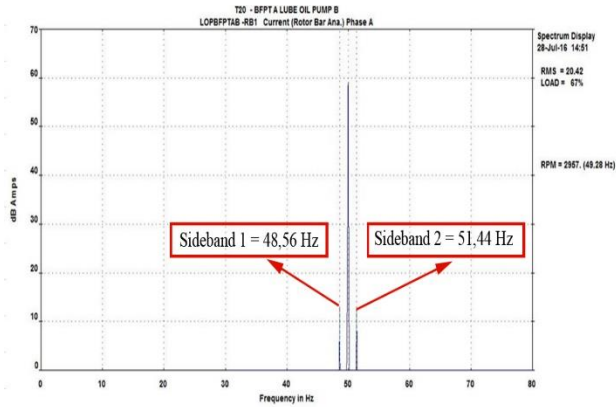
Fig. 9. Sideband frequency that appears between the line frequency

sideband frequency of the MCSA analysis was 1.44 Hz. Based on the sideband frequency value of 1.44 Hz, it can be interpreted that the sideband that appears around the frequency line is 48.56 Hz and 51.44 Hz. The value of the sideband frequency that appears between the line frequency can be seen in Fig. 9.

Furthermore, to determine the indication of the damage to the rotor bar of an induction motor, it can be seen the amount of decrease that occurs between the line frequency and the side band frequency. Determination of the presence or absence of rotor damage must be in accordance with the standards of EASA as shown in Fig. 10. Fig. 10 shows that if the sideband frequency that occurs is -17.32 Hz at the peak of the line frequency of 50 Hz, or if using the Fast Fourier Transform (FFT) algorithm can be converted to a value of -40 dB, it can be determined that the motor is identified with a damage to the rotor bar. By comparing the results of the analysis at low frequency with the standard from EASA, it can be seen that the degradation on the spectrum curve is 44.55 dB, so it can be said that the motor lube oil bfpt pump identifies damage to the rotor bar.

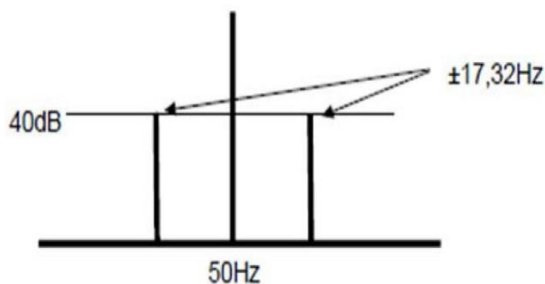
Fig. 10. Standards of EASA for rotor bar of induction motor diagnosis

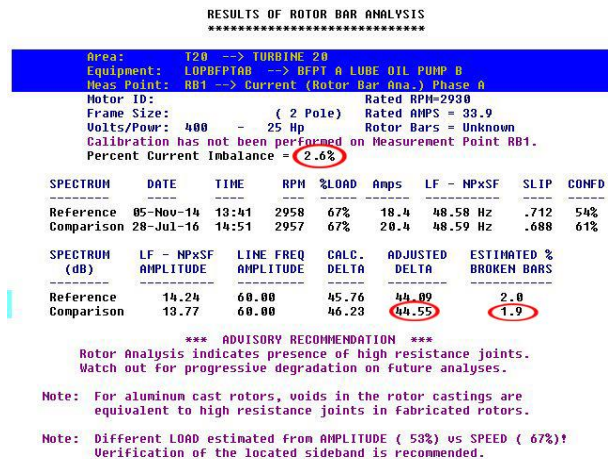
Fig. 11. Results of the analysis of the percentage of unbalanced current of the induction motor when a disturbance occurs using AMS Health Machinery software

The results of the analysis of the percentage of unbalanced current from the induction motor on the motor lube oil bfpt pump when a disturbance occurs which is analyzed using AMS Health Machinery software is shown in Fig. 11.

From the AMS Suite Health Machinery analysis results obtained the percentage of current unbalance data is 2.6%, the adjusted delta is 44.55 dB, and the percentage of damage to the rotor bar is 1.9%.

From the results of experimental data and analysis results obtained percent unbalance flow of 2.6%. The induction motor manufacturer has determined the allowable level for the percent of unbalanced current not to exceed 10%. The imbalance of the current between the phases in a three-phase induction motor

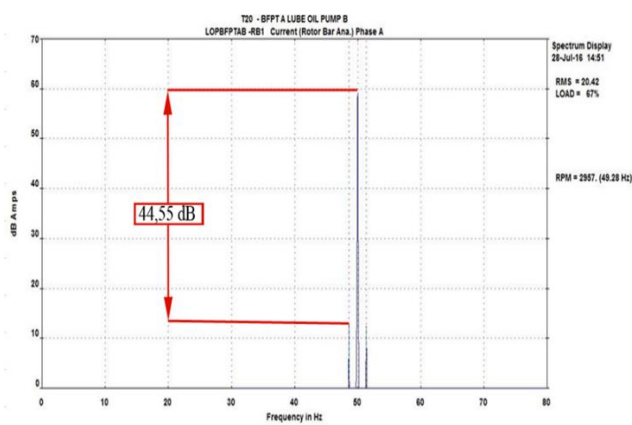
Fig. 12. A signal that indicates a damage to the rotor bar of the induction motor

The estimate for broken rotor bars is 1.9%. If the estimation is getting bigger, the condition of the rotor bar is getting worse. The condition of the rotor bar damage can be seen as shown in Fig. 12. The signal gain (Δ dB) is 44.55 dB. This value is obtained from the difference between the peak frequency and the lower side band. In accordance with the standards of the Electrical Apparatus Service Association (EASA), the data shows the motor is in “marginal condition”.

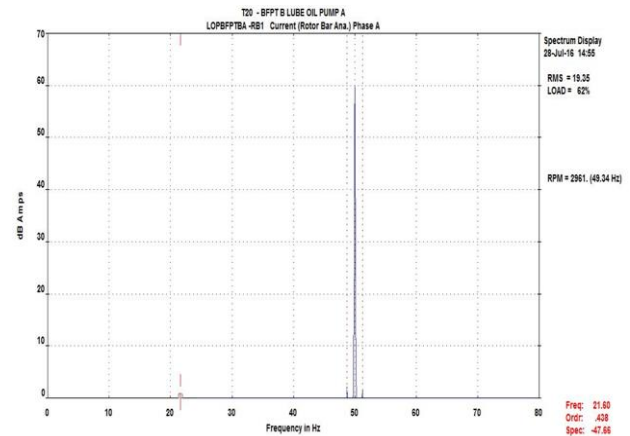
Fig. 13. Current spectrum in the frequency domain from MCSA

After the repair is complete, before using the induction motor, the test is carried out using MCSA. The analysis of the rotor bar was carried out to determine the level of damage to the rotor bar. The results of the analysis using the MCSA tool display the current spectrum in the frequency domain, as shown in Fig. 13.

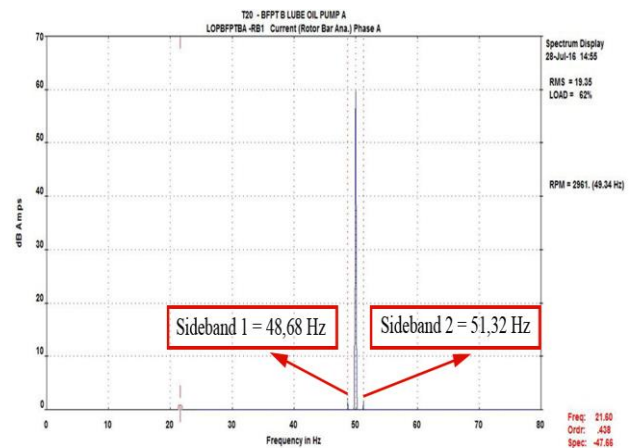
Fig. 14. Sideband frequency that appears between the line frequency

frequency, the side band frequencies that occur around the line frequency can be determined. The sideband frequency of the MCSA analysis was 1.32 Hz. Based on the sideband frequency value of 1.32 Hz, it can be interpreted that the sideband that appears around the frequency line is 48.68 Hz and 51.32 Hz. The value of the sideband frequency that appears between the line frequency can be seen in Fig. 14.

Furthermore, to determine the indication of the damage to the rotor bar of an induction motor, it can be seen the amount of decrease that occurs between the line frequency and the side band frequency. Determination of the presence or absence of rotor damage must be in accordance with the standards of EASA as shown in Fig. 10. Fig. 10 shows that if the sideband frequency that occurs is -17.32 Hz at the peak of the line frequency of 50 Hz, or if using the Fast Fourier Transform (FFT) algorithm can be converted to a value of -40 dB, it can be determined that the motor is identified with a damage to the rotor bar. By comparing the results of the analysis at low frequency with the standard from EASA, it can be seen that the degradation on the spectrum curve is 44.55 dB, so it can be said that the motor lube oil bfpt pump identifies damage to the rotor bar.

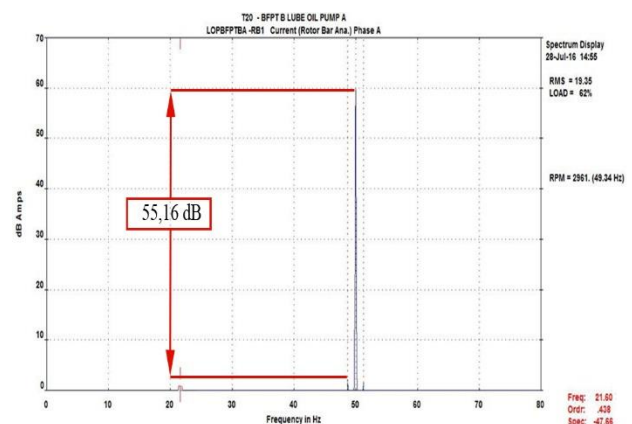
Fig. 16. A signal that indicates a damage to the rotor bar of the induction motor

The estimate for broken rotor bars is 0.6%. If the estimation is getting bigger, the condition of the rotor bar is getting worse. The condition of the rotor bar damage can be seen as shown in Fig. 16. The signal gain (Δ dB) is 55.16 dB. This value is obtained from the difference between the peak frequency and the lower side band. In accordance with the standards of the Electrical Apparatus Service Association (EASA), the data shows the motor is in "normal condition".
