Damage Assessment Method for Light Steel Roof Frames: Case Study of Government Buildings

The tornado disaster in Ciamis Regency damaged 55 buildings, including the Panawangan District Office. The aim of this research was to identify the condition and level of damage to the Light Steel Roof Frame Structures that were damaged and determine the ranking or percentage of damage. By making direct observations at the location of the incident. The result is that: The roof covering element uses zincaluminum metal with the batten frame partially damaged on the left side of the building above the hall and the right corner of the front of the building. The bottom chord, top chord and web elements are partially detached. The trim element made of GRC material is damaged. came loose, and the Gypsum ceiling elements with hollow frames fell on the outside and inside the hall. The percentage of damage obtained is 14.50% and the damage level $\leq 30\%$ is categorized as Light Damage.

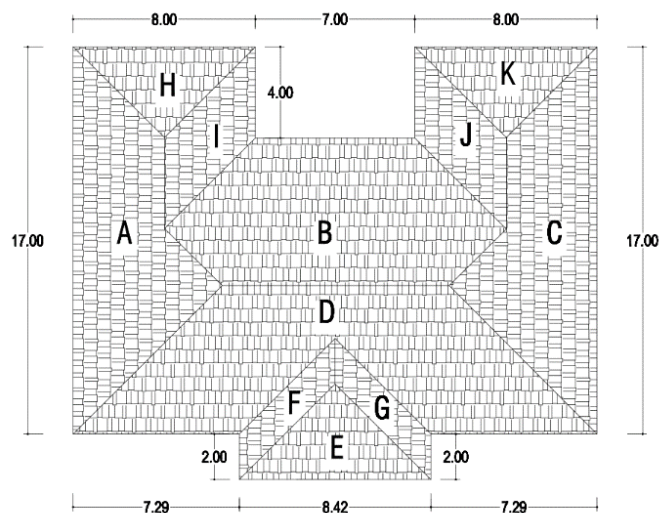
Figure 7. Sketch of the roof plan of the Panawangan District office

Data on the roof area of the Panawangan District Office was taken from calculations of roof area segments coded with segment names on the roof, which are presented in Figure 7.

To find out the total area of the roof of a building in Panawangan District, it is calculated by multiplying the flat area of the roof shown on the plan multiplied by the slope of the roof, presented in Table 2.

Based on Table 2, it is found that the total roof area of the Panawangan District office is 441.03 m²
