Analysis of Coir Fiber/Wood Paint as Composite Anti-Weathering Coatings on Traditional Fishing Boats

The low resistance of wood as a frame material for traditional fishing boats against splashing sea water, humidity, and high-temperature fluctuations was studied in this study by adding coconut coir fiber to wood paint, where this mixture will become an anti-weathering composite material. To make sure that the coir fibers (which absorb water) and the alkyd paints (which don't), have good compatibility with each other, the author treats the coco fibers in a special way by pre-treating them with acetone and then soaking them in a 10% high-temperature sodium hydroxide NaOH solution for a short time. Soaking fibers with a rough surface in this solution can change them and lower hydrogen bonding, which makes the bond between the fiber and the filler in the composite better. The results obtained were that the addition of fiber with a weight fraction of 3.40% to the alkyd paint matrix made the composite the most optimal anti-weathering coating.

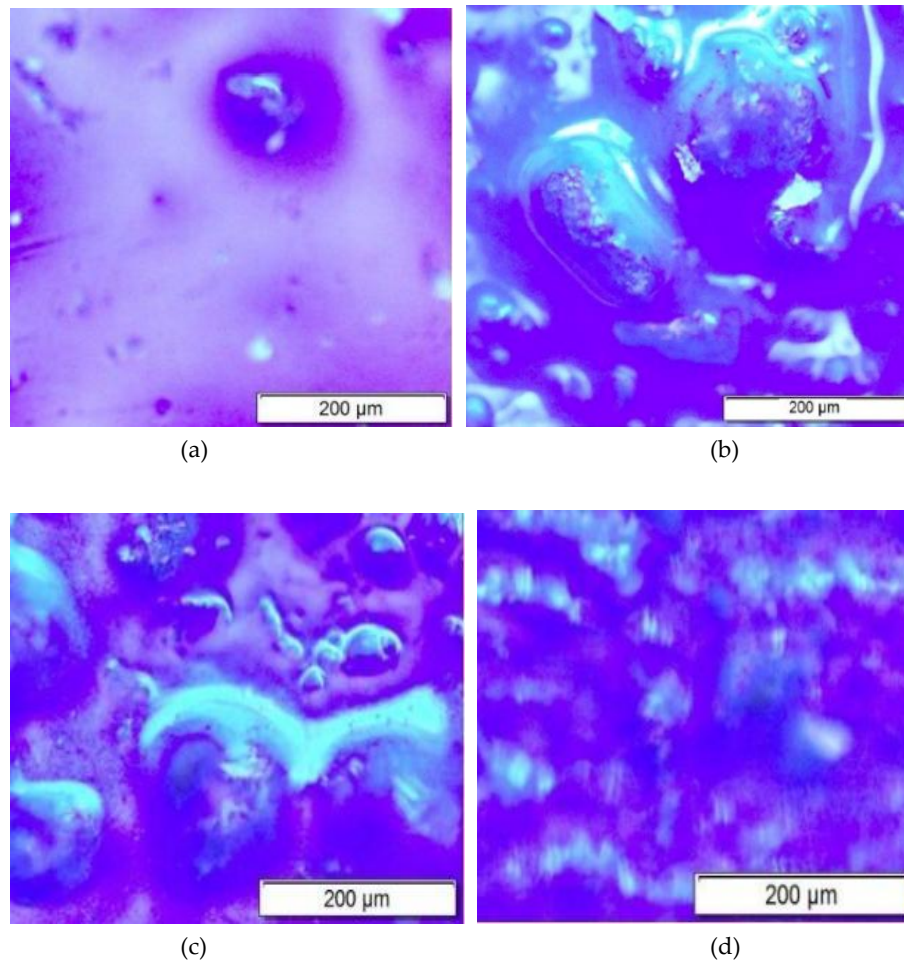
The mixing between coconut coir fiber as reinforcement and alkyd-based paint as a matrix is shown in Figure 1. The fiber grains are seen blending with the paint, which acts as a binder. As the fiber weight fraction increases, the density of the composite becomes higher, as seen from the density of the fibers in order, starting from the lowest density, namely sample A, then B and C. Sample N is a pure base paint or coating without the addition of fiber, which is used as a reference.

Figure 1. Image taken from the OLYMPUS BX5M microscope: (a) sample N, (b) sample A, (c) sample B, and (d) sample C

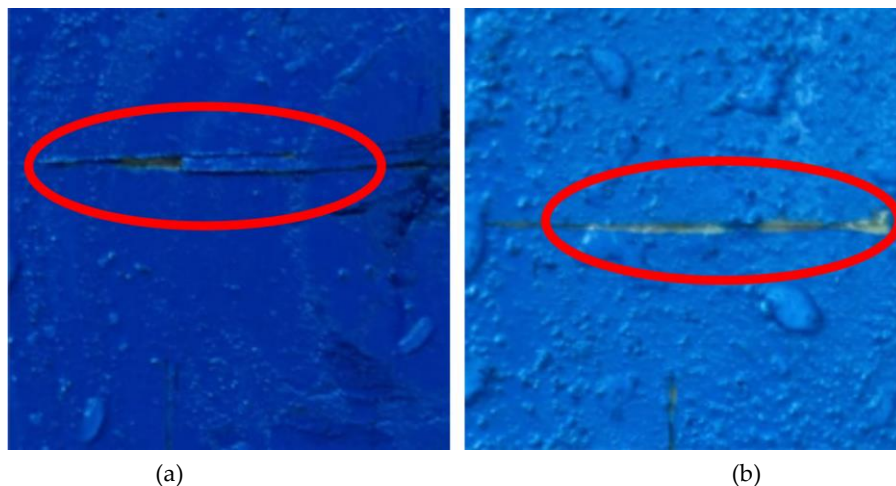
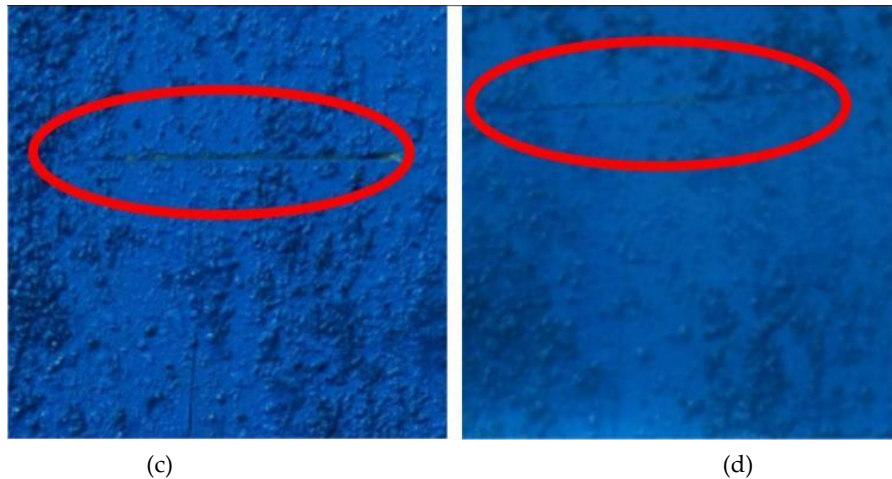
The results of the scratch test and resistance to pressurized waterjet spray are presented in Figure 2. Soaking in a hot alkaline solution is able to make the surface of the fiber and reduce hydrogen bonding, which ultimately reduces its hydrophilic properties [16] [19]. Thus, this alkaline treatment improves the interface adhesion between the fiber and matrix paint, which improves the mechanical properties of the composite as a coating. The addition of the fiber weight fraction increases the test resistance. This is due to the role of coir fiber, which has a tensile strength between 131 MPa and 220 MPa [15], which is able to withstand high-pressure water compared to the sample without the addition of fiber.

Figure 2. Scratch test of (a) sample N, (b) sample A, (c) sample B, and (d) sample C

Sample C showed good performance on scratches and peeling (by spraying with high-pressure water). This is because the fibers that have undergone alkaline treatment can blend with alkyd paints, which are hydrophobic and water-repellent. The existence of fibers that have relatively high tensile strength [A] can withstand pressure, so coatings with fibers have better peeling resistance than those without fibers. The results of the bending test confirmed the role of coir fiber, which has high ductility [B], so the specimens with fiber showed good bending results.

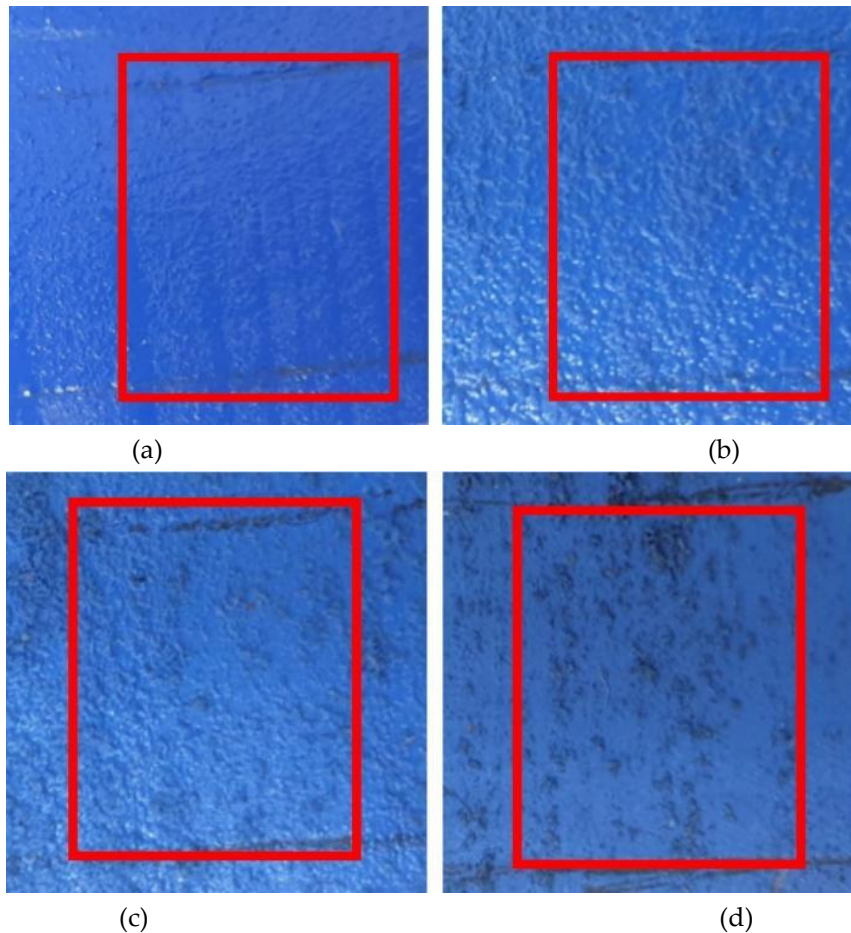
The adhesive characteristic depicted in Figure 3 is based on peel adhesion results. All the samples showed similar behavior, in which no peeling was detected during the test, which proved a good adhesion between the coating and wood as a base material.

Figure 3. Peel test of (a) sample N, (b) sample A, (c) sample B, and (d) sample C

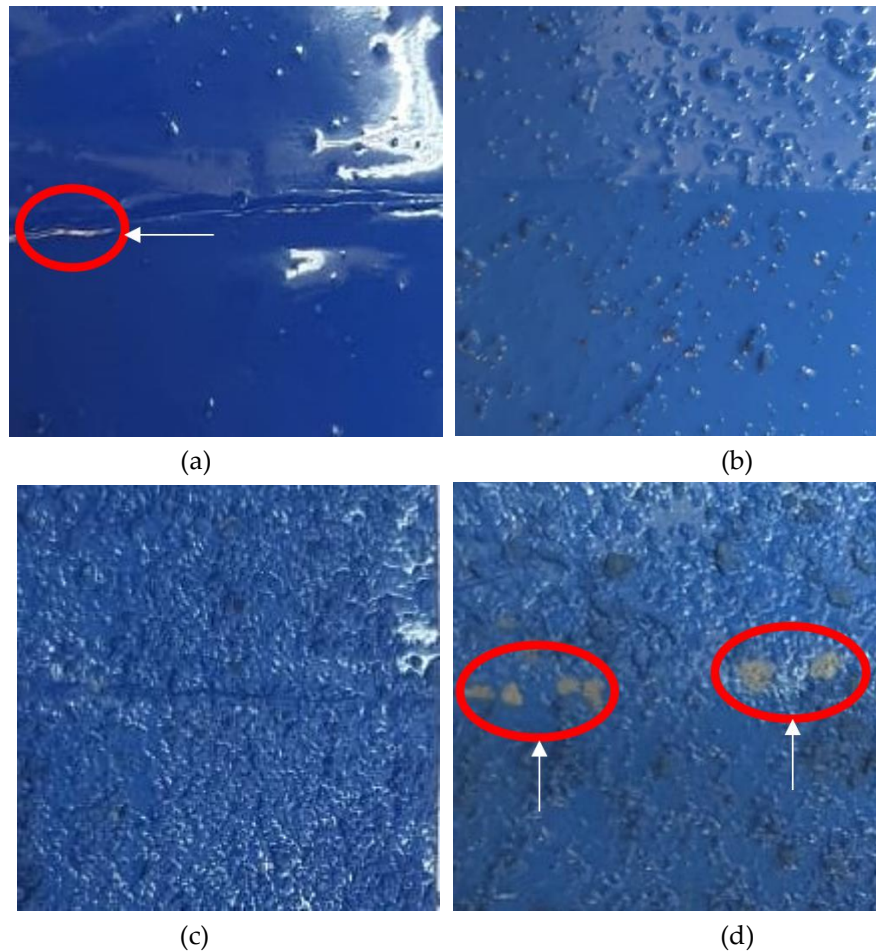
In addition to the scratch and peel test, a flexural/bending test was performed to examine the internal bonding of the composite coating itself. As illustrated in Figure 4, the addition of coir fiber shows high characteristics compared to the sample without fiber. This is due to the high ductility of coconut coir fiber, with a value of around 15%–40%. Although the amount of fiber does not have much effect on ductility, performance is slightly better on sample A, but the tendency to increase the fraction weight will deteriorate

the bending's performance. In that case, the result indicated a substantial plastic behavior in which incompatibility aggregation of the coating composite occurred.

Figure 4. Bending test of (a) sample N, (b) sample A, (c) sample B, and (d) sample C

But adding fibers with a high weight fraction will make it less flexible because the fibers' large size makes it hard for them to bond perfectly with the matrix paint, and the paint's hydrophobic properties do not perfectly change the fibers' properties to match, either. Thus, sample A has the most optimal bending characteristics. Sample A showed the best performance as a fire retardant because coconut coir still had water-absorbing and hydrophilic properties, although it was not too different from samples B and C. This fire-retardant performance was seen when compared to a coating without fiber (sample N). Of all the performance criteria, sample A obtained from fraction weight 3.40 wt%, performed the best as an anti-weathering coating composite for traditional fishermen's boats.

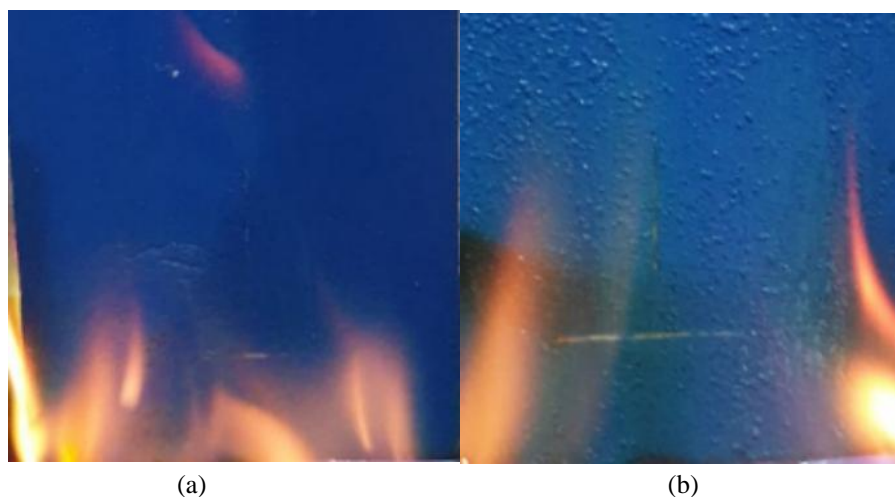
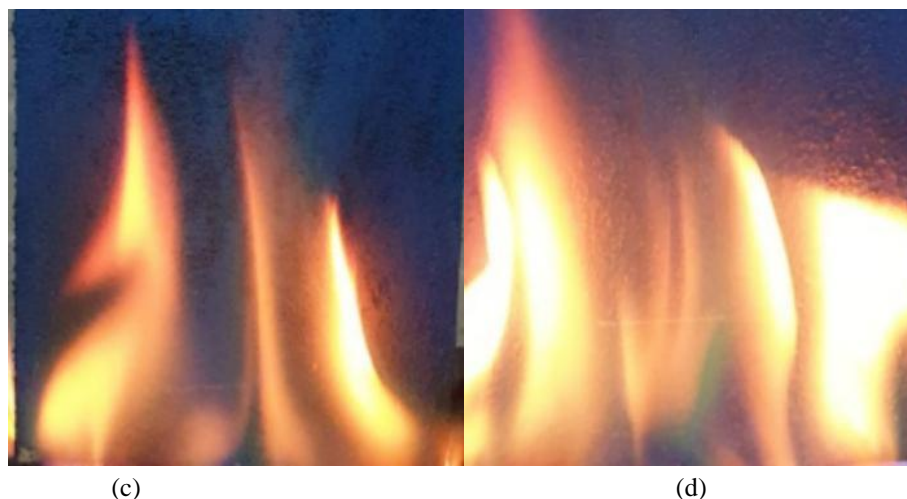
The flame resistance and fire-retardant test concluded that samples A, B, and C have good stability or resistance to fire for the first minutes before the fire spreads to the sample's body compared to sample N. However, as depicted in Figure 5, the speed of the fire spreading after the first few minutes showed that sample N experienced a slowdown compared to other samples that had fiber, except the sample A retained the best stability. This result was due to the presence of fiber, which had reached the melting point, which increased the speed of the fire spread and the reaction of hydrophobic alkyd paint. Sample A may be able to resist fire well because the coir fiber and alkyd-based paint may be able to stick together in the best way.

Figure 5. Fire retardant test after the first minute of burning: (a) sample N, (b) sample A, (c) sample B, and (d) sample C
